**MADISON COUNTY, VIRGINIA**

**CAPITAL IMPROVEMENT PROGRAM**

2012-2016

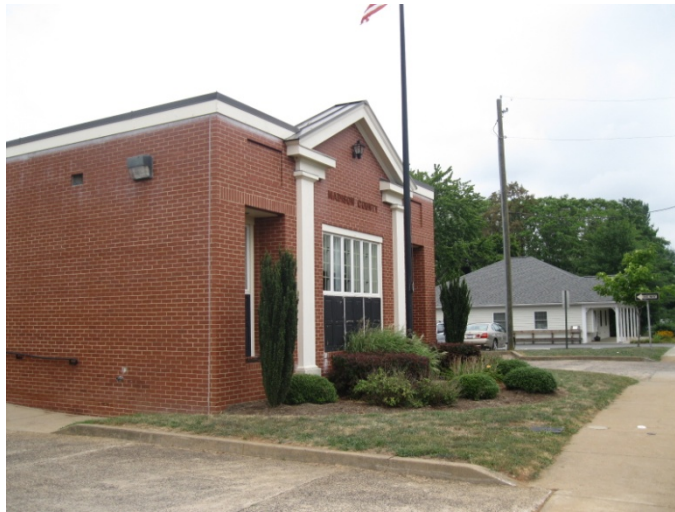
Brick masonry – good condition with some areas requiring minor re-pointing. The windows appear to be double paned insulated glazing with exterior metal storm/screen systems. There is also some wood exterior trim at windows, doors and entries including the small wood framed canopy at the rear entry. Wood shutters have been installed below the metal clad windows at the front of the facility. All exterior wood should be thoroughly inspected for rot, prior to the recommended re-painting.

Original built-up roofing, age unknown, with a spray applied polyurethane foam roof (PUF) system applied on top, in various stages of deterioration. Existing downspouts are metal and need replacing.

The building is heated and air conditioned by gas furnace systems with split coils located in the mechanical room. Ductwork extends from the units to deliver air to each space. The systems appeared to be in fair condition. Age of equipment could not be determined. Replacement of the split systems should occur within the next 5 to 10 years.

- Exterior ramp handrail upgrades to meet current ADA code.
- Provide accessible parking spaces, striped and with proper signage.
- Replace interior door hardware with compliant hardware.
- Short term roof restoration of the PUF roofing system.
- Replace drinking fountain with accessible model at proper height.
- Re-point exterior masonry (minor).
- Repaint exterior wood shutters and wood trim; replace in kind any rotted members.
- Replace interior lighting.
- Replace battery powered egress lighting.
- Upgrade low voltage systems as appropriate for use.
- Replace electrical distribution panels.

- Replace the existing roofing system.
- Replace split HVAC system due to life expectancy of equipment.
- Replace domestic water heater due to life expectancy of equipment.

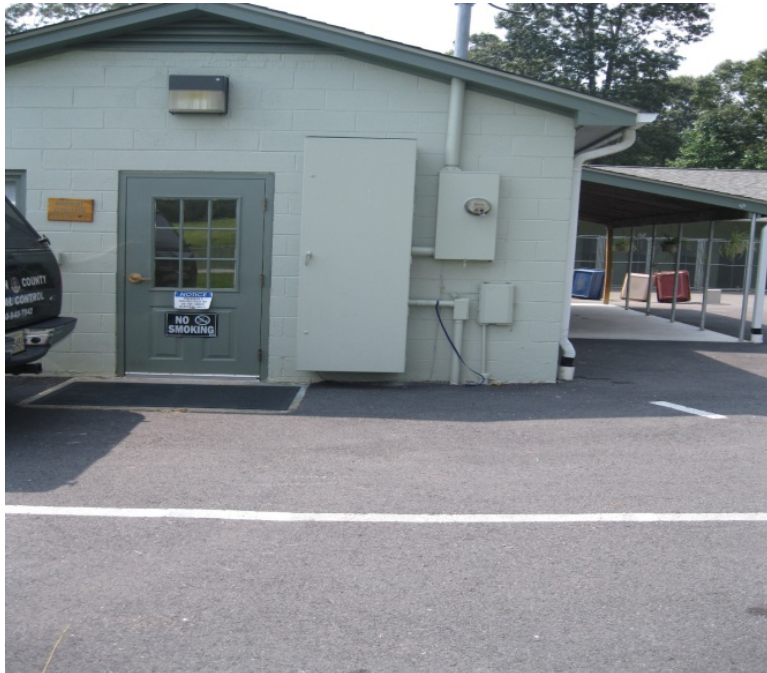
Masonry bearing with wood trusses and plywood or wood joist and beams at shed locations. There is a wood structural post supporting a portion of the side shed roof of the facility, which needs to be replaced.

- Replace exterior wood support column at end of roof overhang as structural member is bent.

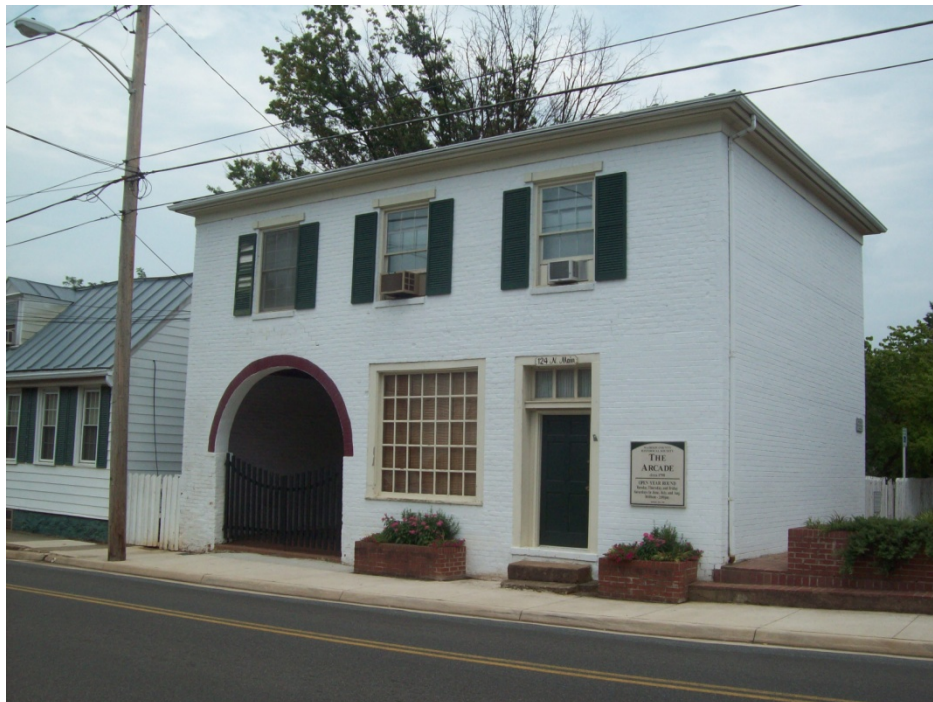
There are some visible step cracks in the brick masonry around the arch portion of the building. The mortar joints should be raked out and replaced to limit further damage to the brick and possible water penetration. There are also a few wood shutters on the building that have missing slates and showing signs of failing with pieces dropping to the sidewalk below. We recommend that the shutters be removed from the building and either re-constructed or replaced.

A small alley exists between the Arcade building and the property to the north. It appears as though water stands in the area and is causing water damage to the brick of the Arcade building. A small drain should be installed if possible to help with this problem. The alley is also overgrown with weeds and should be cleared of vegetation to help with the flow of water.

The exterior walls are solid brick that has been painted. Presently there are some step cracks as noted above that should be re-pointed. The wood windows are single pane and in need of re-glazing and repainting. Most of the windows have been outfitted with a single metal screen. The wood trim is peeling and needs to be scraped and repainted to prevent moisture penetration.

The roof system is standing seam metal roof that appears in good condition. There is a downspout on the south side of the building, along Main Street, that enters the building at the foundation level and likely ties into the storm drainage system. The pipe is cracked where it enters the building and should be repaired.
